HAZARD ALERT

Reversing Equipment in a Shared Work Area

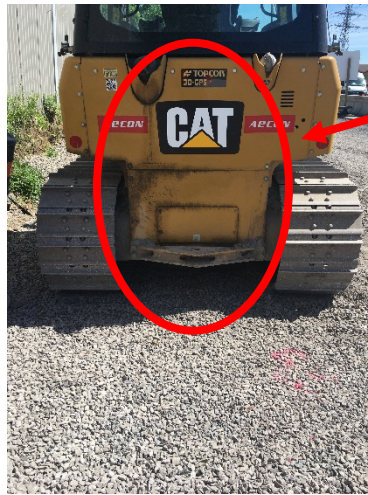
An Aecon employee was checking grade for the placement of granular A material, when he was struck by a reversing D5 dozer. The worker sustained fractures to his pelvic bone, requiring hospitalization and surgery.

- Worker in the Line of Fire
- Lack of communication
- Complacency
- Noise from live traffic adjacent to the work area

Worker was struck by the back plate of the bulldozer.

- Always conduct Job Assessment Risk Reviews (JARRs) to identify potential hazards and controls
- Always follow safe work practices and procedures
- Always ensure a spotter is designated and in place prior to operating equipment
- Never place yourself in the Line of Fire
- Always communicate planned job tasks with other operations in the work area
- Ensure communication between operator and worker(s) are acknowledged by both parties
