HAZARD ALERT

Pinch/Crush Points

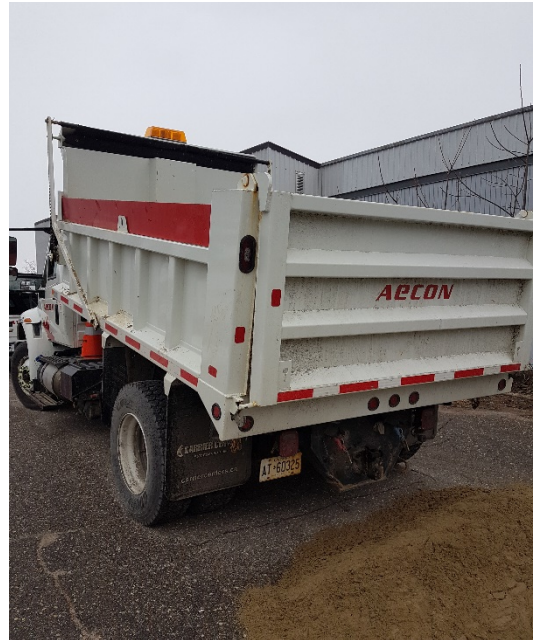
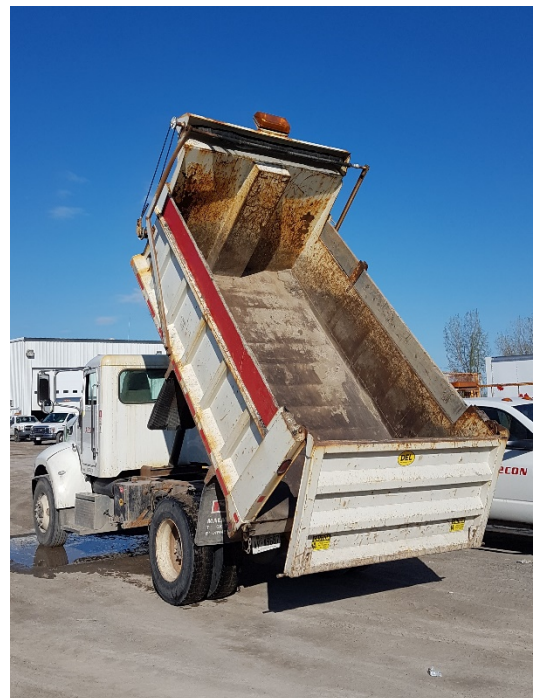
A worker was releasing material from the bed of a partially raised dump truck when they slammed the tailgate to loosen and release material. The worker's hand was pinched between the tailgate and the latch, resulting in a serious injury to the worker's thumb.

- The pinch/crush point hazard was not identified during the JARR assessment.
- Hazards were not reassessed when the truck was positioned under overhead obstruction, limiting the elevation of the box, leading to the worker slamming the tailgate.
- Worker placed his hand in the Line of Fire.

- Always conduct JHA's and JARR cards prior to conducting work activities to identify potential hazards and controls.
- Ensure all workers are aware of potential hazards and safe work practices.
- Always follow safe work practices and procedures.
- If the planned work changes, step back and reassess potential hazards.
- Ensure body positioning does not put worker in Line of Fire.
- If you are not able to unload material at desired location, dump material in a safe location and move material by other means i.e. equipment, wheelbarrow.
- Always stand clear of the back of a raised truck as material could suddenly release.
